Giasin, K., Hawxwell, J., Sinke, J., Dhakal, H., Köklü, U. and Brousseau, E. ORCID: <https://orcid.org/0000-0003-2728-3189> 2020. The effect of cutting tool coating on the form and dimensional errors of machined holes in GLARE® fibre metal laminates. International Journal of Advanced Manufacturing Technology 107 (5-6) , pp. 2817-2832. 10.1007/s00170-020-05211-2 file

Title of the manuscript: "The effect of cutting tool coating on the form and dimensional errors of machined holes in GLARE® fibre metal laminates."

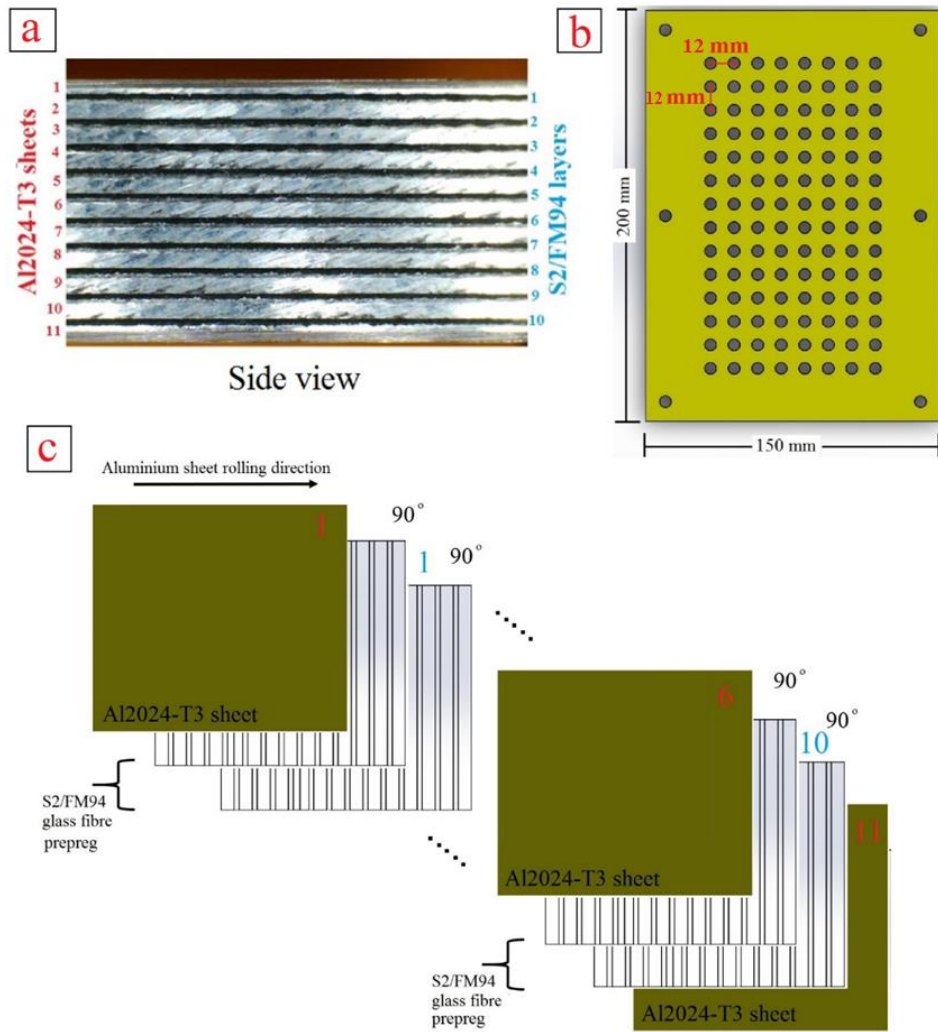
Fig. 1: Details of the GLARE® workpiece used in the current study (a) Side view (b) Front view (c)

Laminate configuration [3, 50]

The workpiece material utilised in this research is a GLARE® 2B laminate as shown in Fig. 1.a. The laminate is made up of Al2024-T3 aluminium sheets and S2/FM94 glass fibre-epoxy layers [3, 4, 6]. The distance between the centres of two holes drilled adjacent to each other was kept constant as illustrated in Fig. 1.b [49]. The workpiece dimensions were 200 mm x 150 mm and approximately 7.13 mm thick. Each glass fibre layer was made up of two plies oriented at 90°/90° with respect to the aluminium rolling direction (0°) as represented with Fig. 1.c.

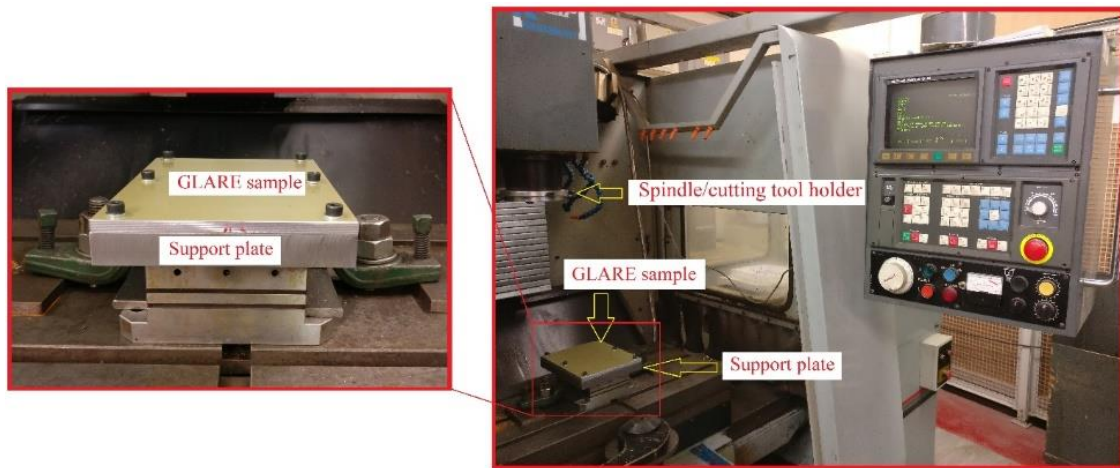
Fig. 2: Setup of the GLARE® laminate inside the CNC machine[49]

A Geo Kingsbury three-axis milling machine was used to drill the holes in the GLARE® workpiece [49]. The sample was placed on the top of a 20 mm thick support plate made from stainless steel to restrict the movement or bending of the laminate similarly to previous studies [3, 4, 6, 22, 49]. The complete setup is shown in Fig. 2. The drilling tests were conducted without the use of any coolants (dry drilling). Additional drilling tests were conducted on a Quaser MV 154-C - CNC milling machine to measure the thrust force. The thrust force was measured using a KISTLER 9257B dynamometer. A DynoWare software, KISTLER 5697A data acquisition system and 5070A 8-channel charge amplifier were used for measurement and data acquisition.

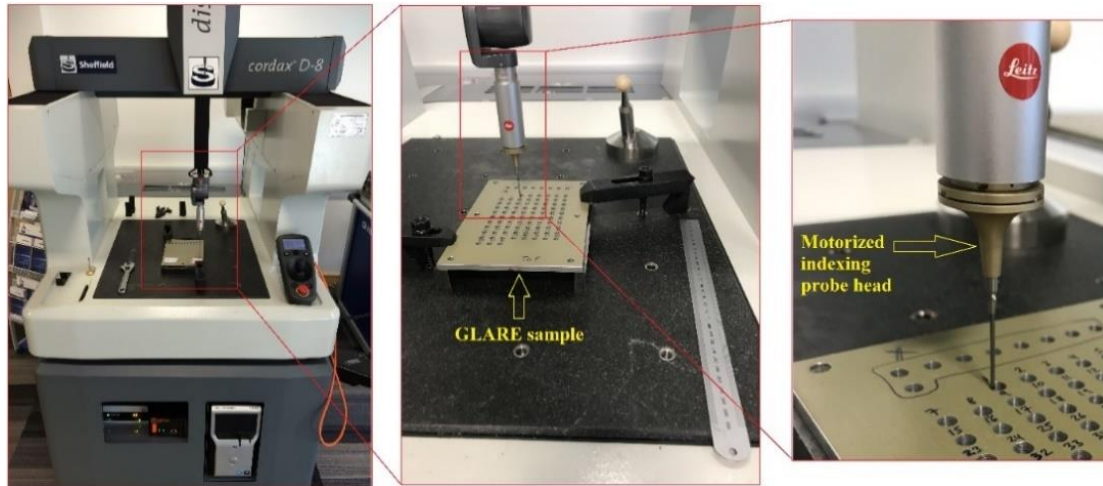
Fig. 3: Measurement of hole geometrical tolerances

The hole geometrical tolerances (hole size, circularity, perpendicularity and cylindricity) were measured using a Sheffield Cordax-D8 Discovery III Coordinate Measurement Machine (CMM) [2-4]. The workpiece was clamped on the CMM table as shown in Fig. 3 and the measurements were taken at two locations at the top and the bottom of each hole (1 mm and 6 mm, respectively). A Leitz stylus equipped with a 2 mm ruby probe was employed to scan the borehole with an average of 30 contacts per mm at a scanning speed of 0.5 mm/sec using an LSP-X1s probe head. The machine accuracy factory specification is $4.9+5L/1000 \mu\text{m}$, the maximum uncertainty reported in the calibration report of the machine was $0.97 \mu\text{m}$. A Mitutoyo Crysta-Apex S776 CMM was used to measure a set of drills sizes before drilling. The MPE_E (Maximum Permissible Error) of the CMM used to measure the sizes of the drills was $1.7+3L/1000$, while the MPE_E of the CMM is used to measure hole tolerances was $4.9+5L/1000 \mu\text{m}$. MPE_E follows the form of $\text{MPE}_E=A+L/K$, where A is a constant (μm) specified by the manufacturer, K is a dimensionless constant specified by the manufacturer and L is the measured length (mm) in this case is 6 mm. Therefore, the accuracies at which the CMM measure the distance between any two points up to a distance of 6 mm for the two CMM machines used in this study were $0.0349 \mu\text{m}$ and $0.0197 \mu\text{m}$. The drills diameters for TiN, TiAlN and AlTiN/TiAlN coated tools were found to be 6.0146 mm, 5.994 mm and 5.9965 mm, respectively.

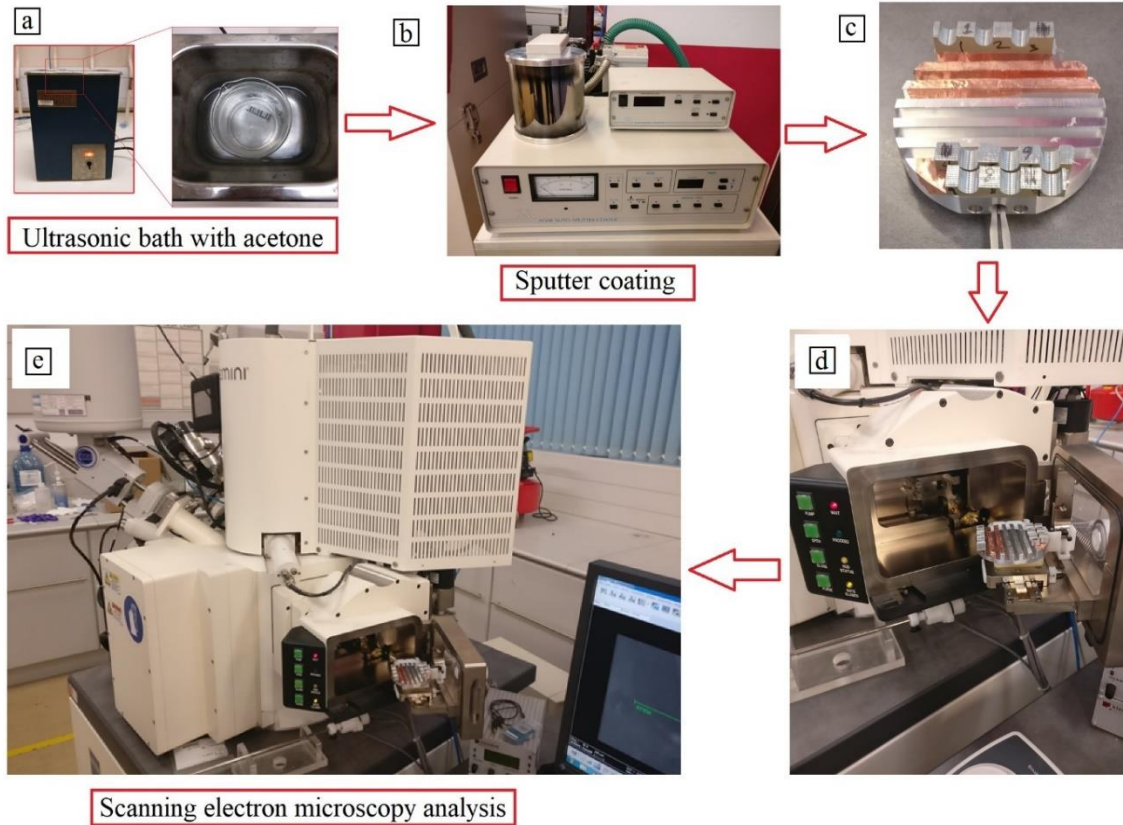
Fig. 4: Sample preparation for SEM analysis (a) ultrasonic bath with acetone (b) sputter coating (c) mounting base (d) interlock chamber (e) Carl Zeiss 1540 XB SEM

SEM was employed to inspect the machined hole surface for any drilling-induced damage. Each hole was cut in half and was then subjected to an ultrasonic bath to eliminate any unwanted debris from the borehole surface as shown in Fig. 4.a. The sectioned holes were then sputter-coated before the inspection with the SEM (Fig. 4.b). They were then secured on a platform using a copper double-sided tape before inspecting them as shown with Fig. 4.c and d. 35-500X magnifications and 10 keV voltage were applied to visualise the borehole walls as necessary.

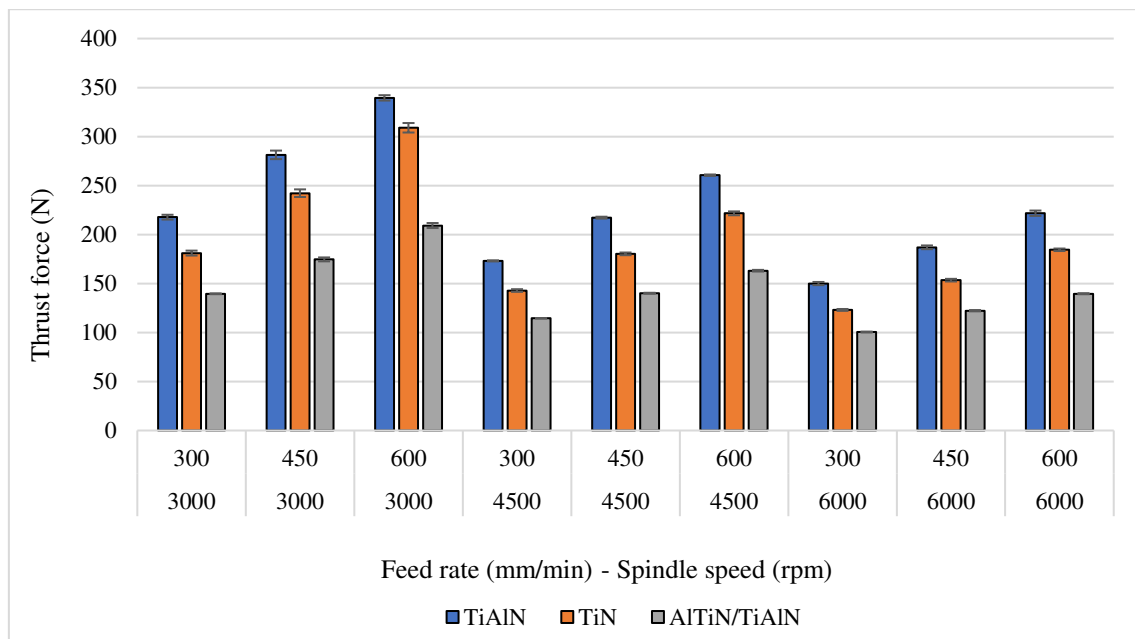
Fig. 5: Thrust force results for different types of drill coating

Fig. 5 shows the average thrust force from the three runs for each tool coating under different cutting parameters. It is noticeable that the TiAlN drills consistently produced the largest thrust force under all cutting parameters, followed by the TiN and AlTiN/TiAlN drills, respectively. It is also observed from this figure that increasing the feed rate increased the thrust force, while increasing the spindle speed decreased it, which is in agreement with previous studies on the drilling of GLARE® laminates [3, 6]. The thrust force recorded using TiAlN drills was between 9.87% and 21.86% higher than that recorded using TiN tools under the same cutting parameters. Similarly, the thrust force recorded using TiAlN drills was between 49.26% and 62.27% higher than that recorded using AlTiN/TiAlN tools.

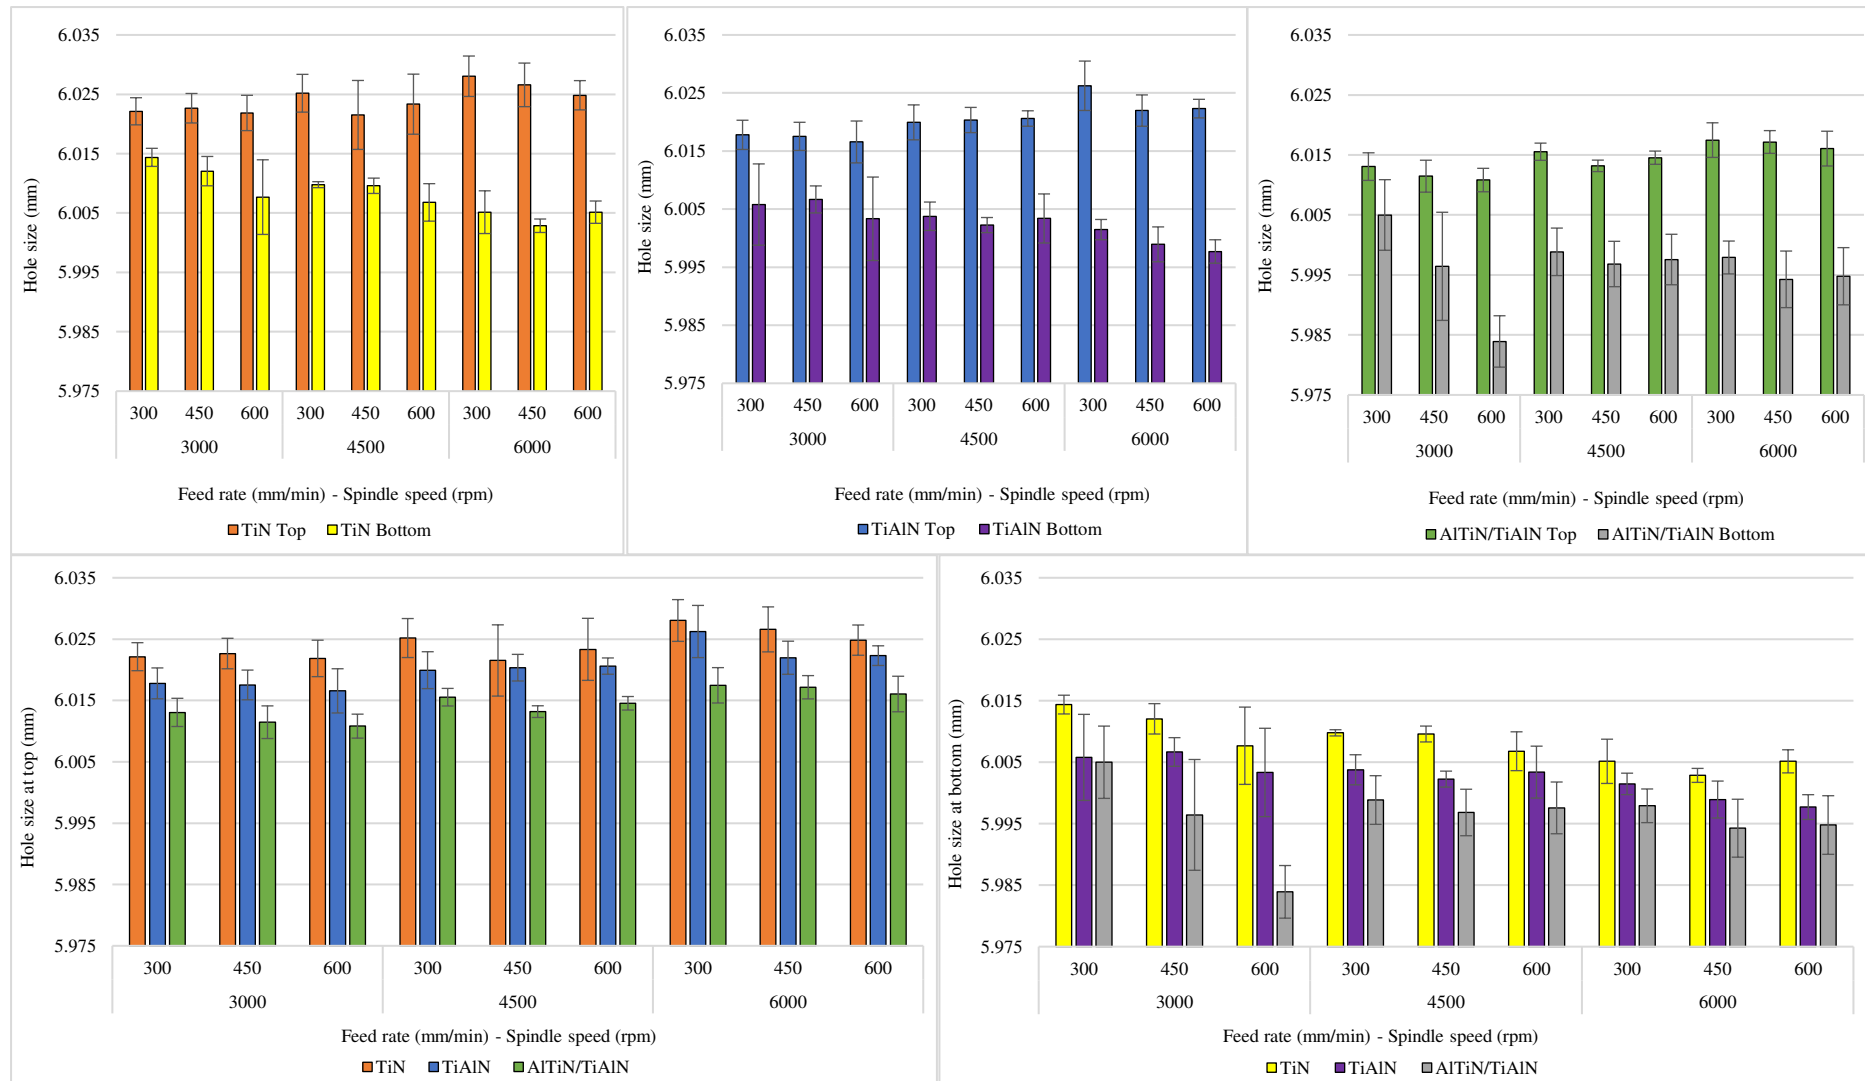
Fig. 6: Hole size for different types of coating at top and bottom location

Fig. 6 shows the average hole size obtained when drilling the GLARE[®] sample under different drilling parameters and drill coatings for both the top and bottom regions of the hole. Overall, the hole size at the top ranged between 6.010 and 6.028 mm, while this range decreased between 5.98 and 6.014 mm at the bottom. Similar results were reported in previous studies in drilling GLARE[®] and Al2024 alloy [3, 22, 25, 53]. Oversized holes were produced at the top regardless of the type of drill coating or drilling parameters used. It should be noted that all drills were produced with a tolerance range of +4 μm to +16 μm . In addition, there was a significant variation in the drill diameters as shown previously in section 2.4. For this reason, it is argued that no firm conclusion may be made from the direct observation of Fig. 6 in terms of which drill coating resulted in the largest hole oversize. Instead, one can use data in Fig. 6 to analyse the relative reduction in the hole diameter between the top and the bottom region for a given type of coating. The average reduction in hole size between the top and the bottom region was 15.86 μm , 17.78 μm and 18.19 μm for TiN, TiAlN and AlTiN/TiAlN coated drills, respectively. Hole shrinkage is common when drilling composites due to the relaxation of the lamina [22, 54]. Therefore, the lower coefficient of friction of TiN coated drills compared to the other two coatings might have caused a lower temperature at the cutting zone leading to reduced hole shrinkage with depth. If the actual drill size for each coating is considered when comparing the measured hole sizes obtained by the three coatings, then TiN coated drills produced holes with least deviation from the drill original size followed by AlTiN/TiAlN and TiAlN coatings, respectively. However, this requires further investigation which will be carried out in a future study.

The largest hole deviation from the nominal value on the top region took place when drilling at the highest spindle speed, i.e. $n = 6000$ rpm, with the lowest feed rate, i.e. $f = 300$ mm/min. This may be due to increased drill vibration at higher spindle speed values [55]. On the contrary, the smallest hole deviation at the top occurred when drilling at the lowest spindle speed, i.e. $n = 3000$ rpm, and with the highest feed rate, $f = 600$ mm/min, except for the drills with TiN coating where the smallest deviation was achieved at

$n = 4500$ rpm and $f = 450$ mm/min. On the bottom region, the largest hole deviation from the nominal value occurred for a different set of drilling conditions for each of the drill coating. This may indicate that the impact of drill coating on hole size becomes more significant with the increase in hole depth.

From the data presented in Fig. 6, it can also be said that, generally, the hole size on the top increased with the increase of spindle speed and decreased on the bottom surface with the increase of the spindle speed when drilling at constant feed rate. Thus, different phenomena, related to the increase in spindle speed, occur at the entrance and exit of the holes. For the bottom region, the continuous rubbing of the drill and evacuated hot chips increase the temperature at the cutting zone leading to thermal shrinkage [56]. This does not happen at the top surface as the more dominant influence in this region is the drill vibration. Finally, it can also be noted that drilling at the following combinations of feed rates and spindle speeds of 300/3000, 450/4500, 600/6000 ((mm/min)/rpm) showed that hole size at top tended to increase while at the bottom, it tended to decrease with the reduction of drilling time.

The ANOVA analysis provided in Table 5 shows that the parameters drill coating and spindle speed had a significant impact on hole size on the top region with 52.4% and 15.0% contribution, respectively. For the bottom region, the ANOVA results imply that all three input parameters had a significant impact on hole size. However, the dominant contribution came from the parameter drill coating with 42.4%, thus confirming an earlier comment made when discussing the results of Fig. 6.

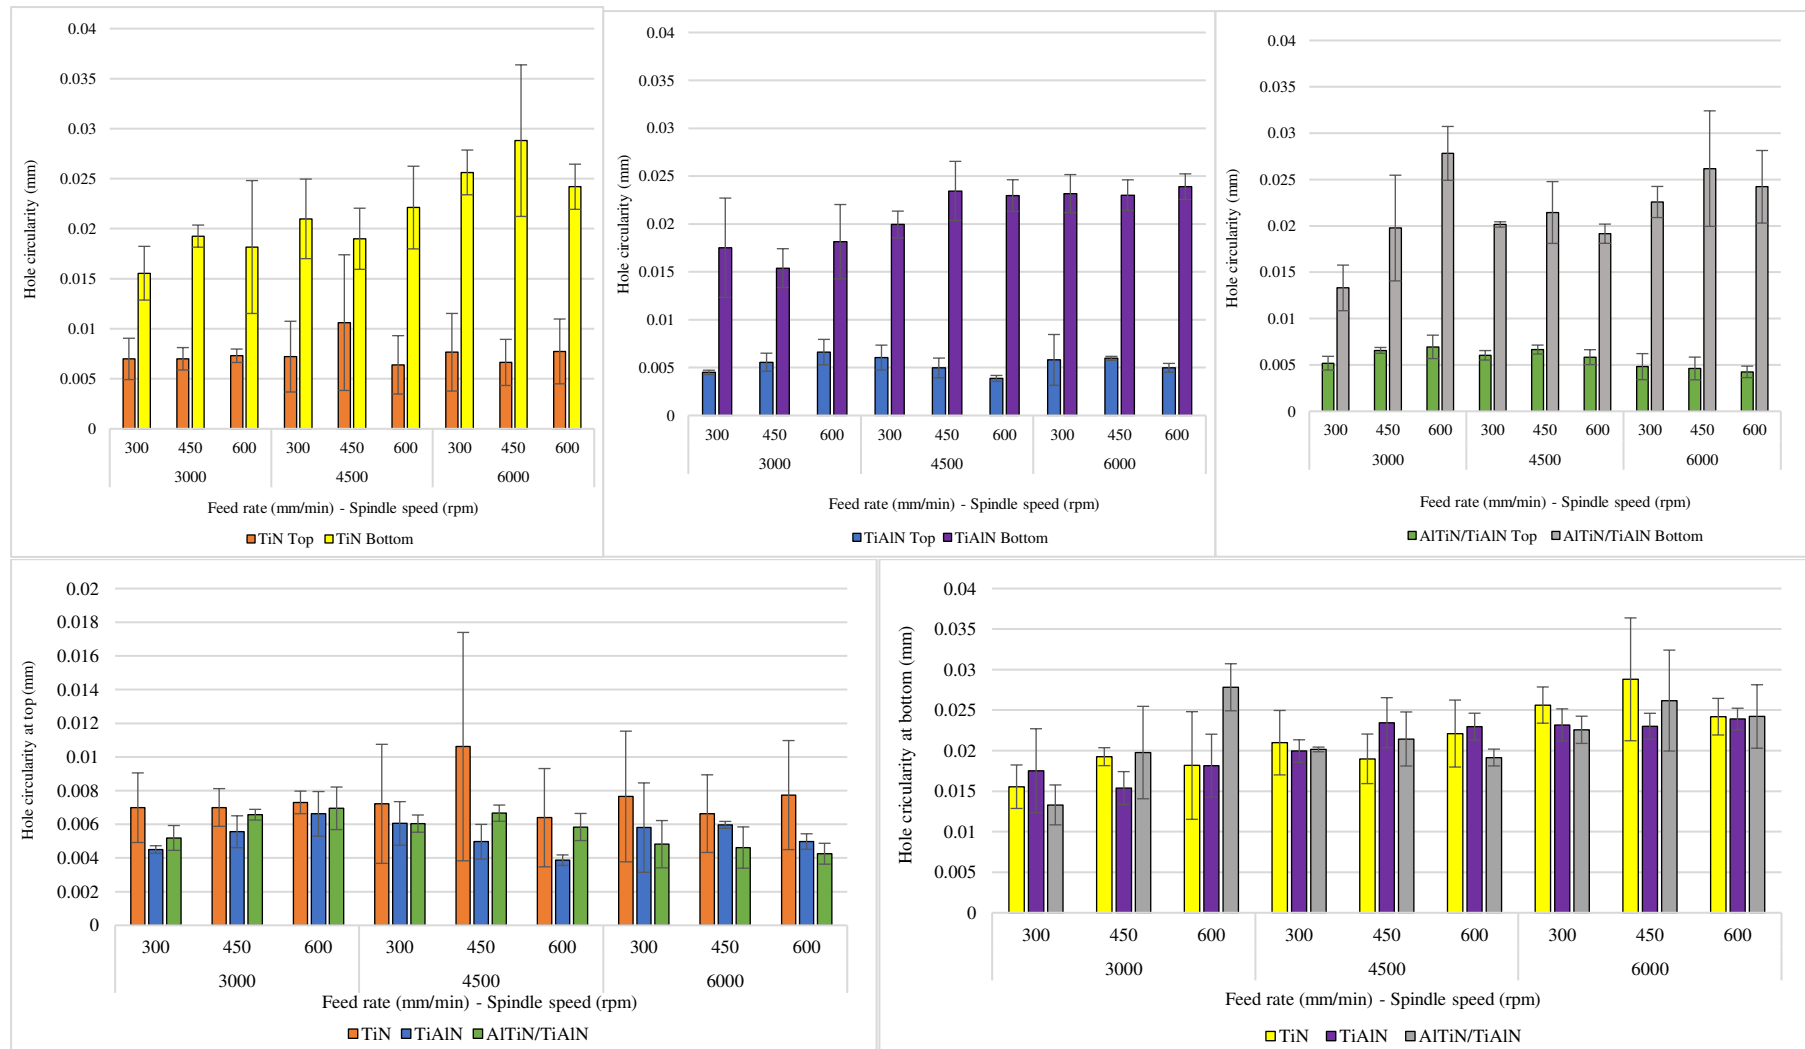
Fig. 7: Hole circularity for different types of coating at top and bottom

Fig. 7 shows the average hole circularity in the GLARE® sample under different drilling parameters and drill coatings at the top and bottom regions. Overall, the average hole circularity on the top was better as it ranged between 3.08 and 10.6 μm , while at the bottom, it was between 13.3 and 28.8 μm . The results are in line with circularity data reported in previous studies on drilling same grade and thickness of GLARE® laminates, particularly the fact that hole circularity is likely to worsen with depth due to the gradual increase in thermal load while cutting through the material and the non-isotropic nature of the coefficient of thermal expansion of the glass fibre layers [3, 22, 25]. However, this observation disagrees with previous studies on drilling metals which report that the deviation from circularity at the hole inlet is worse than that at the hole outlet due to the dynamic instability of the drill during its initial contact with the workpiece. The better values observed at the outlet in holes drilled in metallic materials were reportedly due to self-pointing guidance action of the hole to the drill with increasing depth [59-61]. Other studies on drilling aluminium alloys reported that there are highly non-linear variations in hole circularity throughout the depth of the hole due to the presence of other factors such as fixture/machine drill vibration/drill deflections and damping characteristics [25, 53]. In addition, there was a significant variation in the drill diameters as shown previously in section 2.4. For this reason, it is argued that no firm conclusion may be made from the direct observation of Fig. 7 in terms of which drill coating resulted in the least hole circularity. Instead, one can use data in Fig. 7 to analyse the relative difference in the hole circularity between the top and the bottom region for a given type of coating. The variation in repetitions was significant at the bottom which could be due to the weakening of the hole structure with the reduction in material thickness to be removed from the hole as the drill progresses towards the exit side of the hole. It is also speculated that there might be some other factors affecting those holes tolerances such as the location of the hole and the clamping technique. Such factors will be considered for investigation in future studies.

When considering all the experimental data, the worst hole circularity on the top region occurred when drilling at $n = 4500$ rpm, $f = 450$ mm/min using TiN coating, while the best hole circularity was achieved when drilling at $n = 4500$ rpm, $f = 600$ mm/min using TiAlN coating. Generally, for TiN coated drills, hole circularity at the top region deteriorated with the increase of the spindle speed. For both TiAlN and AlTiN/TiAlN coated drills, hole circularity on the top region became better with the increase in spindle speed except for the lowest feed rate value considered.

Regarding the circularity of holes on the bottom region, for TiN coating, it tended to worsen with the increase of the spindle speed at all feed rates. For AlTiN/TiAlN coating, the hole circularity at the bottom tended to worsen

with the increase of the feed rate when drilling at $n = 3000$ rpm, while it tended to worsen then become better with the increase of the feed rate when drilling at spindle speeds of $n = 4500$ and $n = 6000$ rpm. Drilling at feed rate/spindle speed ratios of 0.1 (0.1 mm/rev) showed that hole circularity at the top tended to be worst when drilling at of $n = 4500$ and $f = 450$ mm/min. However, at the bottom, the hole circularity tended to worsen with the reduction of drilling time which indicates that drilling at faster rates will be on the expense of worsening hole circularity.

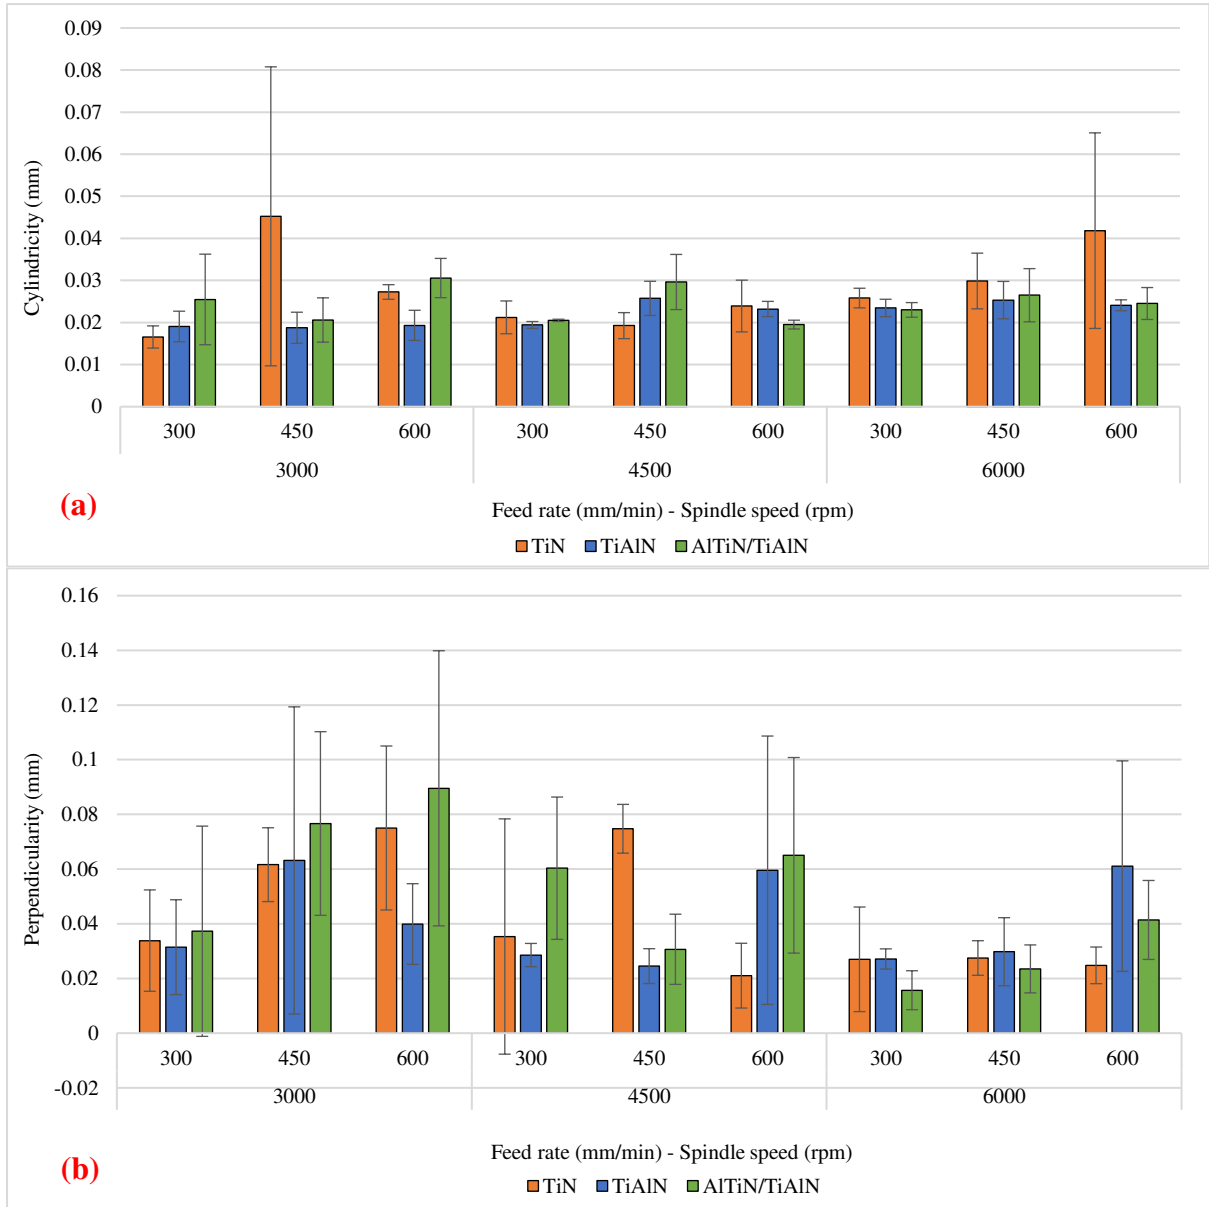
Fig. 8: Hole (a) Cylindricity (b) Perpendicularity

in Fig. 8.a. The worse hole cylindricity occurred using TiN coating when drilling at a spindle speed of $n = 3000$ rpm and a feed rate of $f = 450$ mm/min. The best hole cylindricity occurred using TiN coating when drilling at a spindle speed of $n = 3000$ rpm and a feed rate of $f = 300$ mm/min. Hole cylindricity tended to worsen with the increase of the feed rate when drilling at spindle speeds of $n = 4500$ and 6000 rpm using TiN coated drills. For TiAlN and AlTiN/TiAlN coated drills, hole cylindricity tended to deteriorate and then improve with the increase of feed rate at spindle speeds of $n = 4500$ and 6000 rpm.

Hole perpendicularity became worse with the increase of the feed rate when drilling at a spindle speed of $n = 3000$ rpm for TiN and AlTiN/TiAlN coatings. A similar trend is observed with the increase of the feed rate when drilling at a spindle speed of $n = 6000$ rpm for TiAlN and AlTiN/TiAlN coatings, which could be due to the increase in feed force and vibrations with the increase of the feed rate [4]. The average hole perpendicularity ranged from 0.015 to 0.089 mm, the highest and lowest perpendicularity was found to occur when drilling using AlTiN/TiAlN coating at $n = 6000$ rpm and $f = 300$ mm/min and $n = 3000$ rpm and $f = 600$ mm/min, respectively.

It is also worth to mention that the poor repeatability in hole perpendicularity data suggest that other input factors/parameters might have had an influence on hole perpendicularity which were not investigated in the current study [4]. One of the suggested factors is the location of the hole within the workpiece and the clamping setup of the laminate inside the CNC machine which will be investigated in a future study. In addition, the large errors in hole cylindricity and perpendicularity are common when measured for drilled holes in GLARE laminates as reported by previous studies [2, 3].

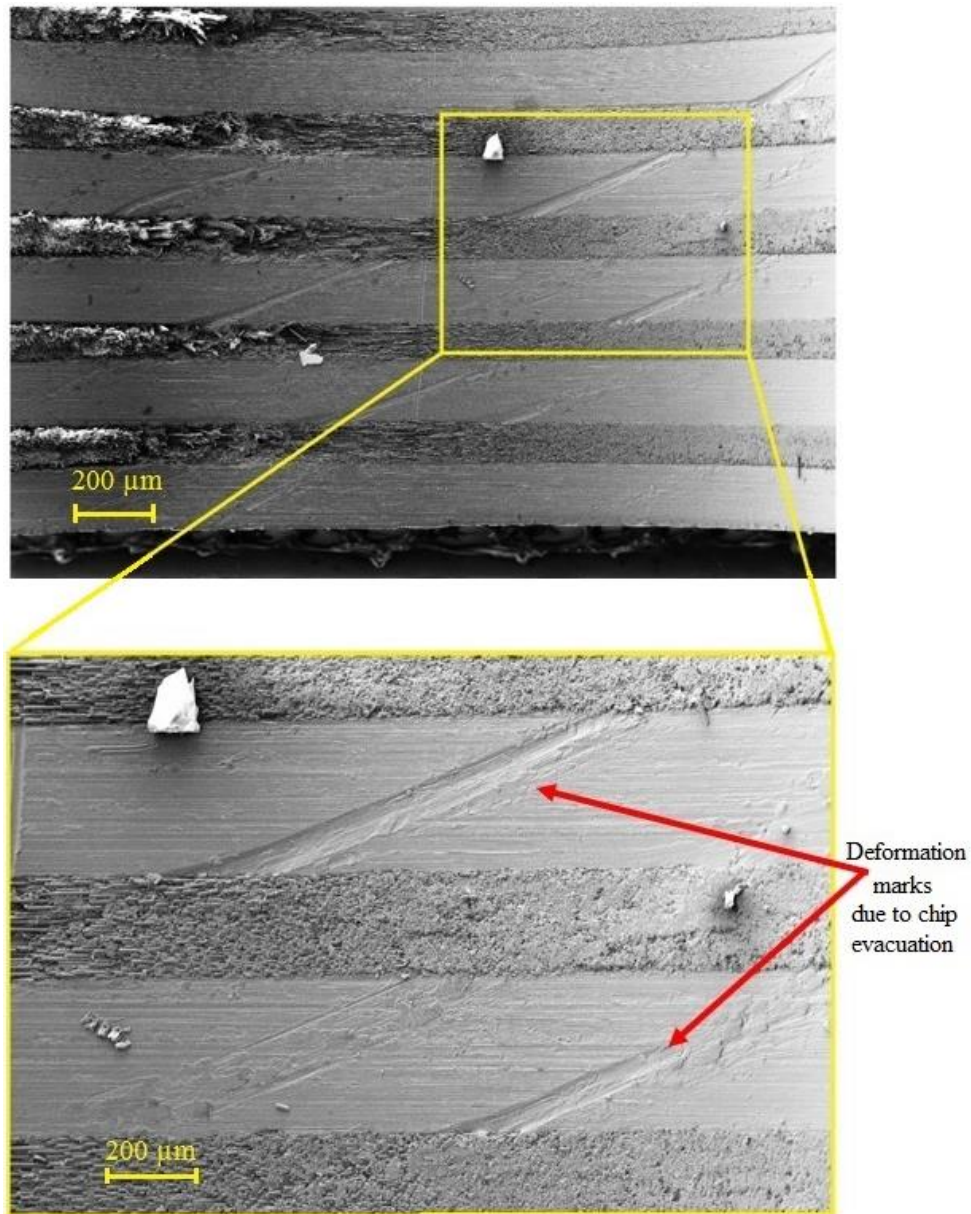
Fig. 9: SEM image of a borehole wall at $f = 300$ mm/min and $n = 3000$ rpm using a TiN coated drill

SEM images reported with Fig. 9 and Fig. 10 reveal that minor metal chipping, interlayer burrs, broken fibres and deformation marks on the surface of aluminium sheets can be observed due to contact with the drill. The types of damage resemble those observed in previously reported studies on drilling GLARE® under dry conditions [2, 3, 50]. The SEM inspection showed that the damage on the hole surface increased with hole depth. Smearing (plastic deformation) and other forms of deformation marks were observed on the surfaces of aluminium sheets which seemed to occur more frequently at higher feed rates which is in-line with observations reported in a previous study [50]. Those deformation marks shown in Fig. 9 and Fig. 10 may be due to two distinct contact scenarios. The first type of deformation marks is speculated to be caused by the rubbing action of the metallic chips colliding with the hole walls while they are leaving the workpiece as shown in Fig. 9. In this case, the marks are helical in shape which resembles the profile of the flute of the twist drill and is of several millimetres in length. This type of deformation marks could be also caused by the fierce rubbing on the hole walls due to vibrations and loss of drill eccentricity while it cuts through the material.

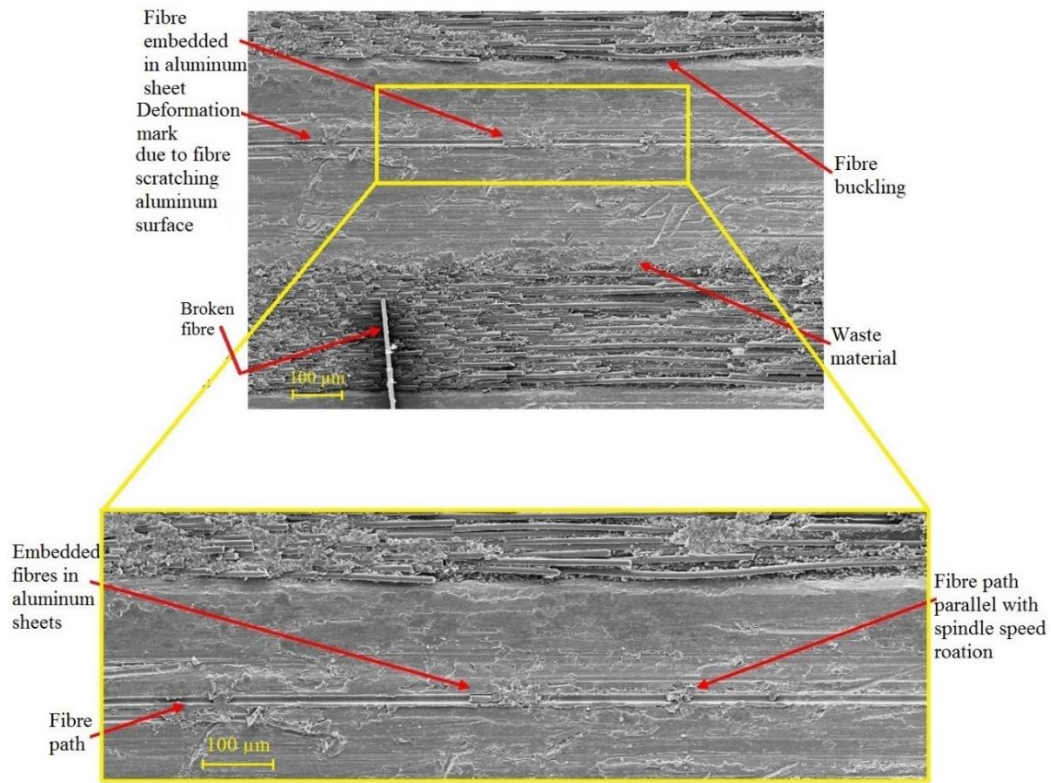
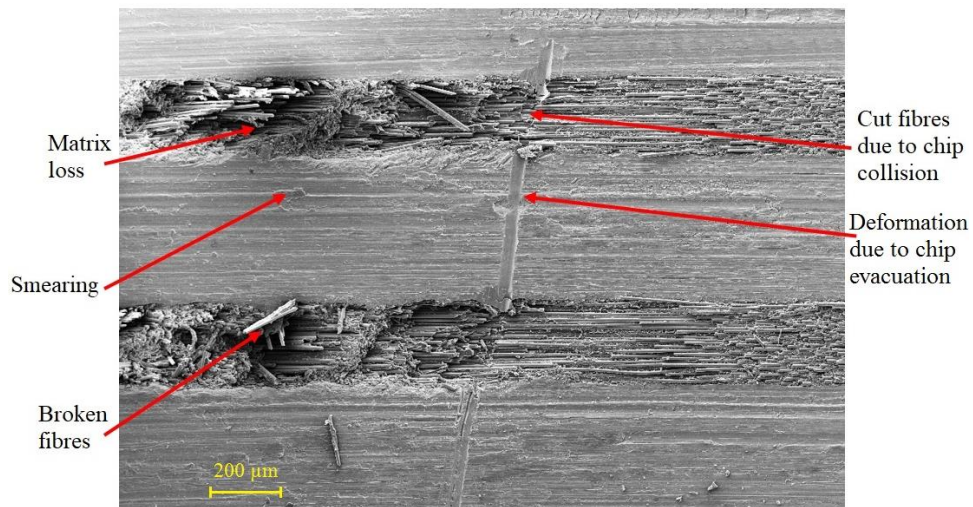
Fig. 10: SEM image of a borehole wall at (a) $f = 300$ mm/min and $n = 4500$ rpm using a AlTiN/TiAlN coated drill (b) at $f = 300$ mm/min and $n = 6000$ rpm for TiAlN coated drill

The second type of deformation marks is speculated to be caused by broken fibres which are trapped between the drill and borehole surface, causing them to be stressed onto the aluminium sheets and plastically deform their outer surface. In this case, the deformation marks appear to be parallel to the fibres as shown in Fig. 10.a. multiple instances of this type of marks were observed on the aluminium sheet. Some of the aluminium chips and broken glass fibres are not evacuated through the drill flutes and are eventually stressed into the edges of the aluminium sheets or into the voids formed in the glass fibre layers due to fibre pull-outs [50] as shown in Fig. 10.b.

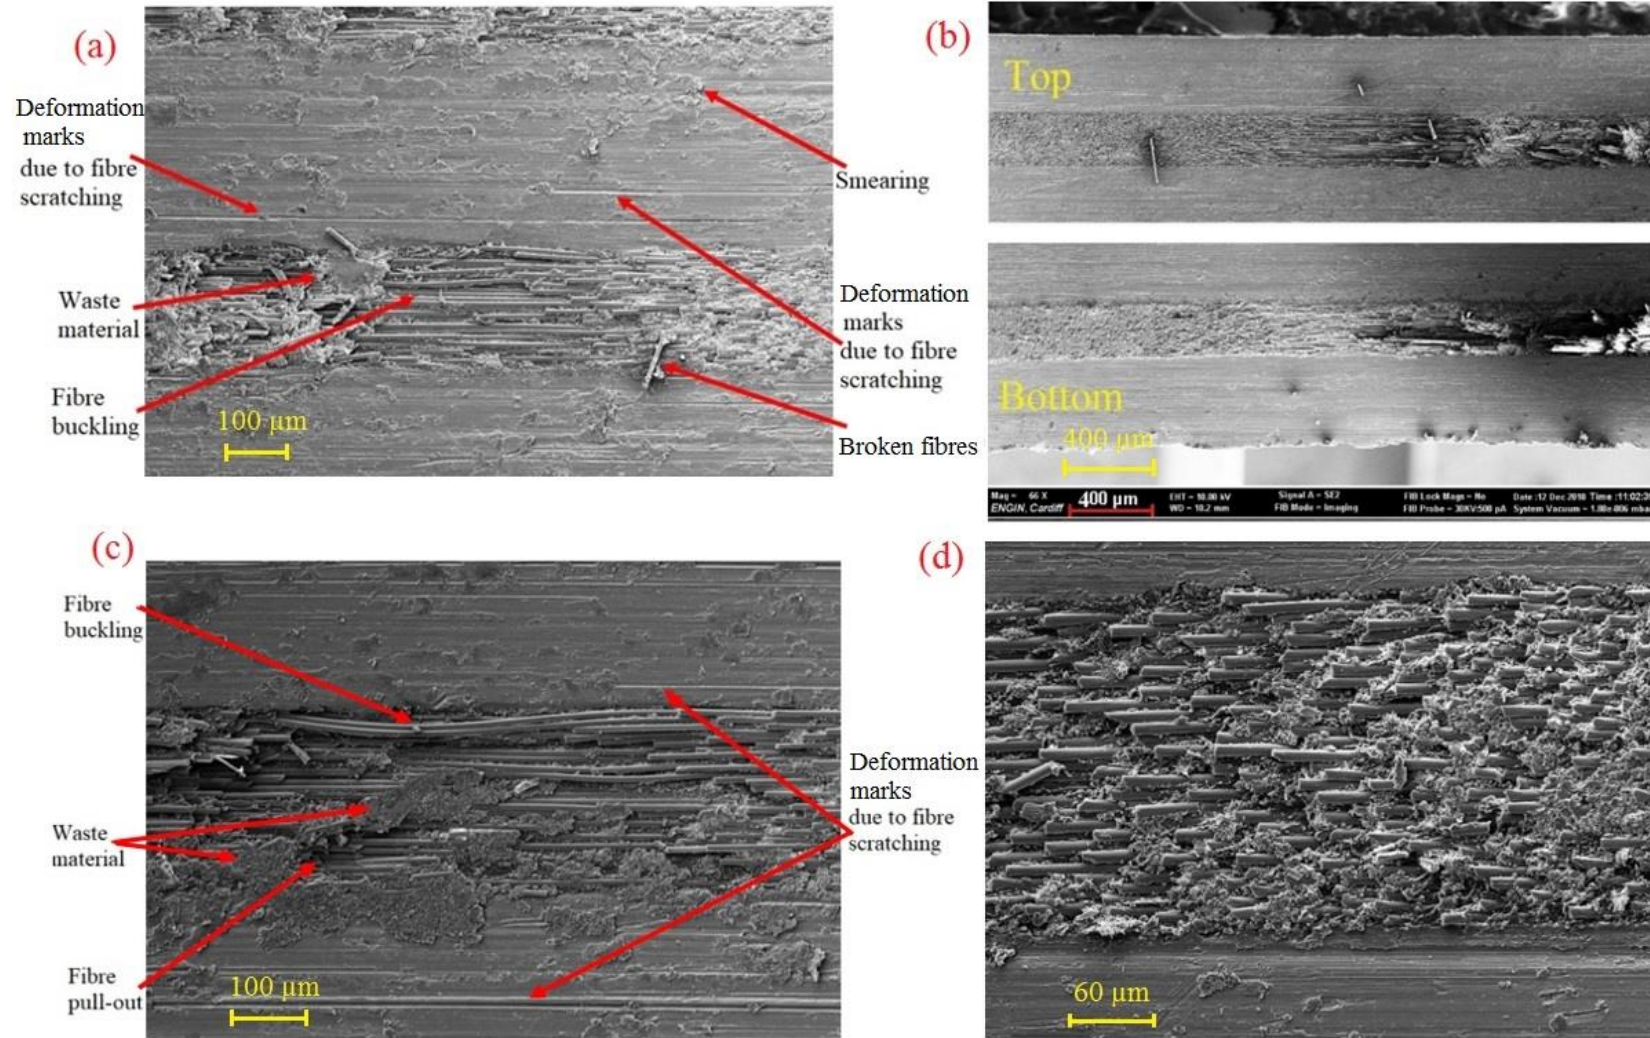
Fig. 11: SEM image of a borehole wall at (a) $f = 300$ mm/min and $n = 3000$ rpm using a AlTiN/TiAlN coated drill (b) the upper and lower aluminium sheets edges at $f = 300$ mm/min and $n = 3000$ rpm using a TiN coated drill (c) $f = 300$ mm/min and $n = 3000$ rpm using a AlTiN/TiAlN coated drill (d) showing fibres with different uncut lengths at $f = 450$ mm/min and $n = 3000$ rpm using a TiN coated drill

Delamination (Type I) was present in the machined holes which takes place due to the progression of the drill into the laminate causing the peeled layers to bend either permanently due to plastic deformation or temporarily like a cantilever beam [3, 62]. A type II fibre buckling can be seen in Fig. 11.c due to compressive loading acting along their direction. Some chunks of fibres end with varying lengths were pointing out due to cutting by fracture as shown in Fig. 11.d [3, 50, 62].
